NCSU - Lake Gaston Vegetation Management Plan Update April 6th, 2022

AQUATIC PLANT MANAGEMENT

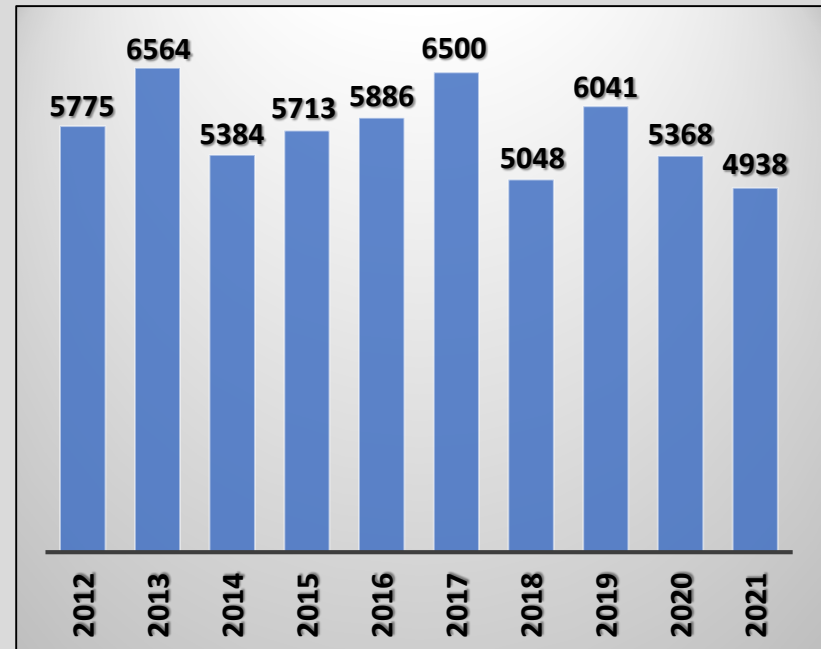
Fall Volunteer Survey

- **70+ Volunteers**
 - *The more volunteers the better!*
 - *Don't have to be associated with LGA or NCSU*
- **Conducted from Sept. 1st to Nov. 11th**
- **4,938 Points Collected**

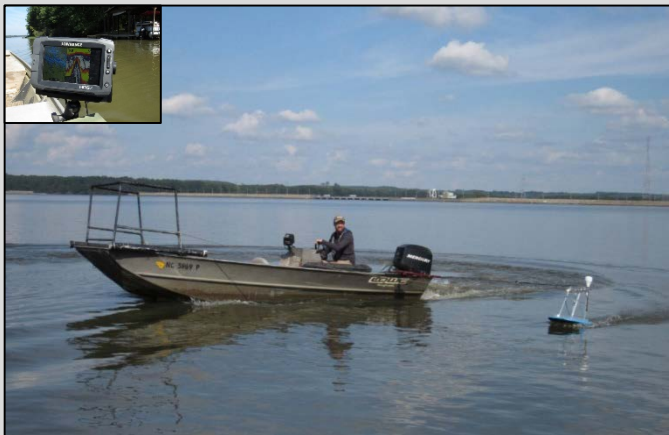
- Entire Shoreline Sampled
- Dual Track Sonar
- September and October
- Data uploaded to BioBase
 - Calculate BioVolume

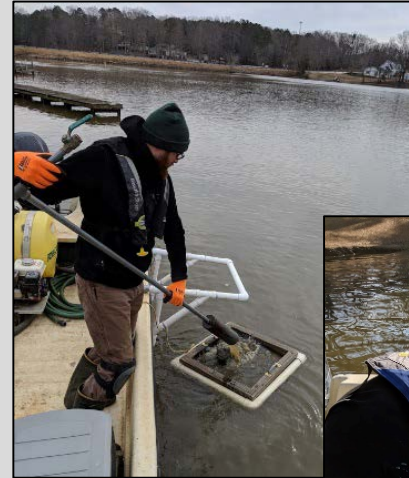
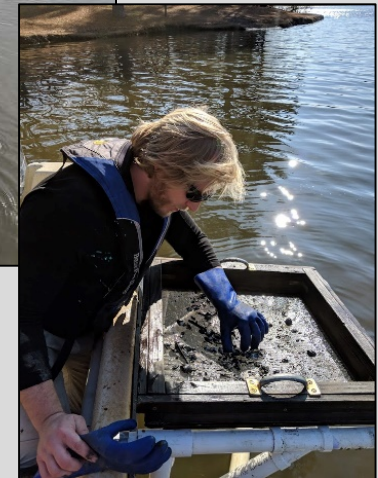
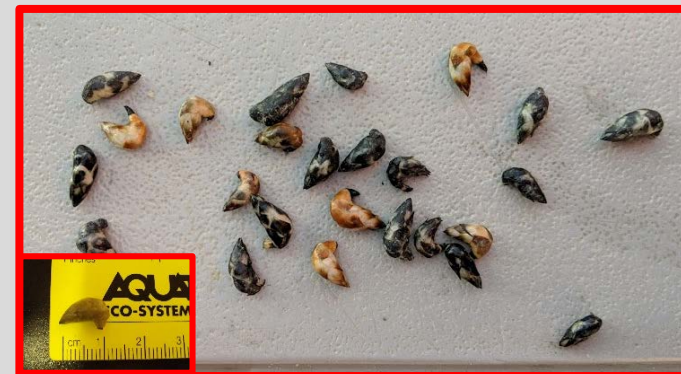
- Sampled December 2021
- 18 Total Creeks
 - Based on historical hydrilla presence
 - 3 – 6 sample sites per creek
- Samples are Collected Using Core Sampler
- Samples Rinsed Over Screen to Exposed Tubers
- Total of 30 - 50 core samples per sample site
- Tuber Densities Calculated per Site
 - Sites are averaged per creek

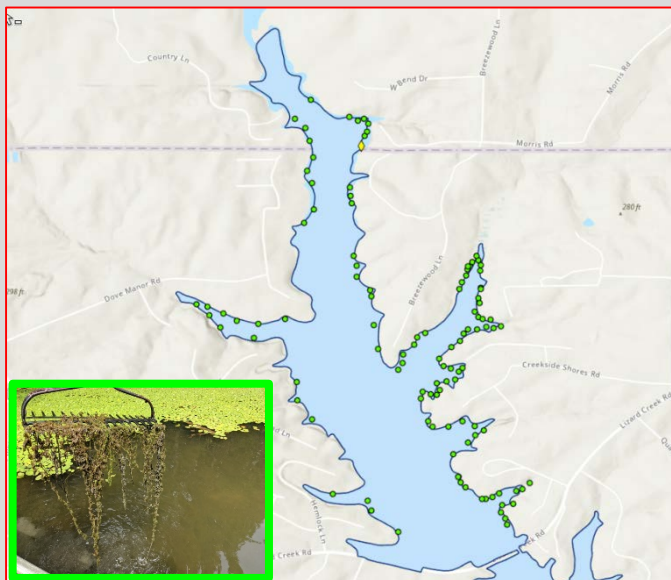
- Tuber Bank Density
- Chara Refuge

2014	2015	2016	2017	2018	2019	2020	2021
Lizard Creek	58.93	30.15	3.29	0.00	49.34	18.91	0.00	24.39

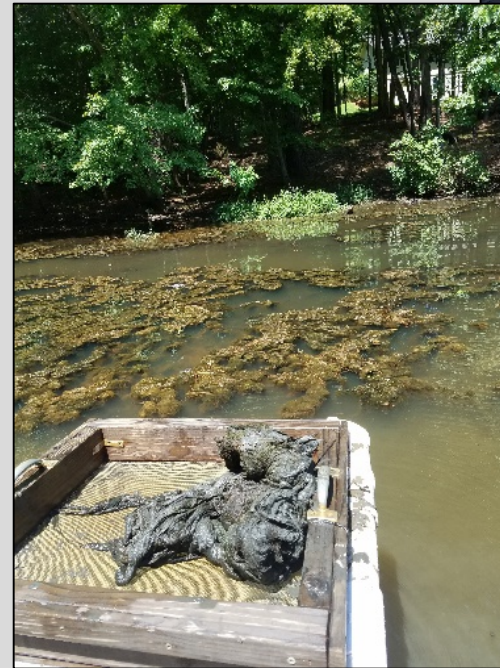
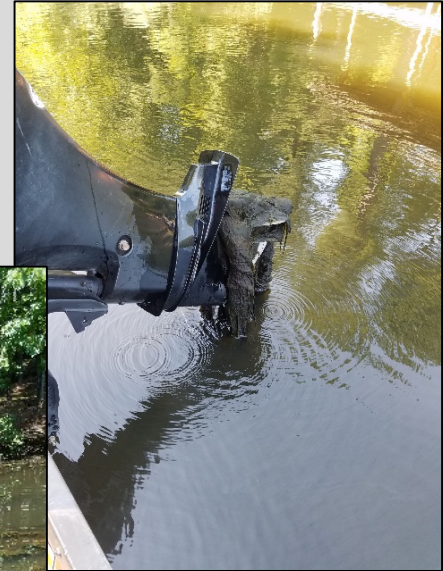
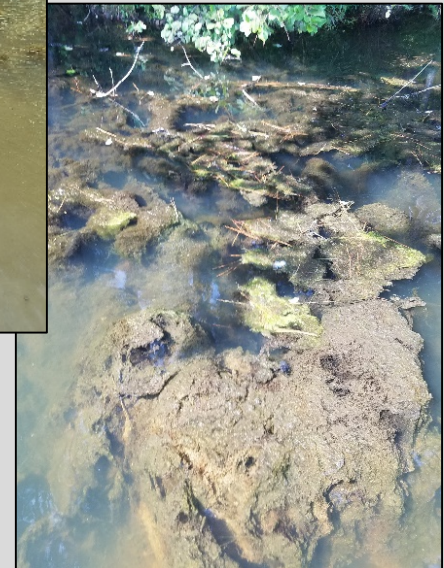
Lyngbya

- Filamentous Cyanobacteria
- Negative Effects:
 - Ecosystem Dynamics
 - Recreational Usage
 - Overall Aesthetics
- Surface Mats Prevalent During Summer Months
- Stinks!

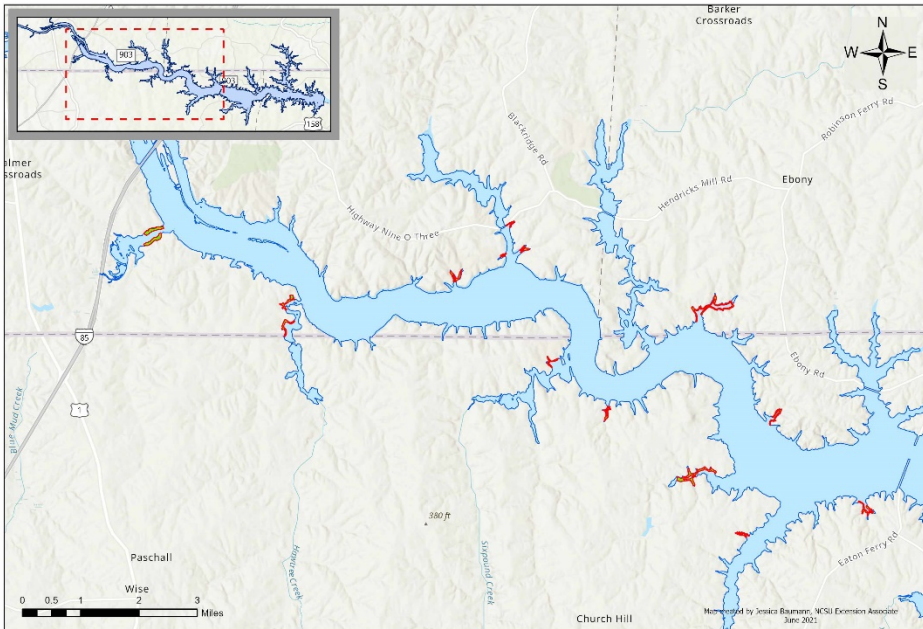
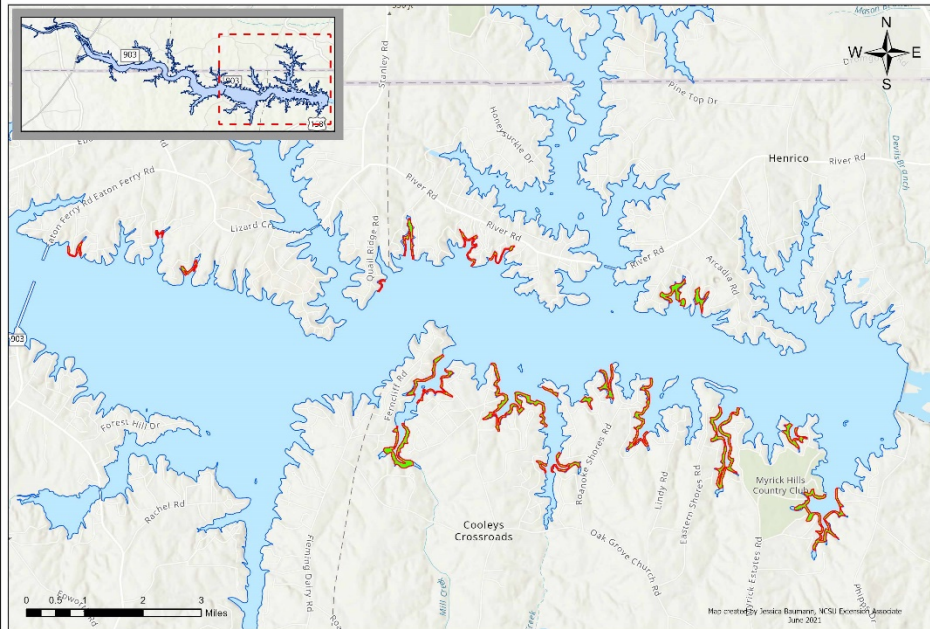
**Lyngbya Treatment Sites - 2021
Lake Gaston, NC/VA**

Monthly Applications (April – September)

Two Treatment Combinations

Varying Treatment Acreage
1 – 26 acres

Varying Copper Rates
0.25 – 0.80 ppm

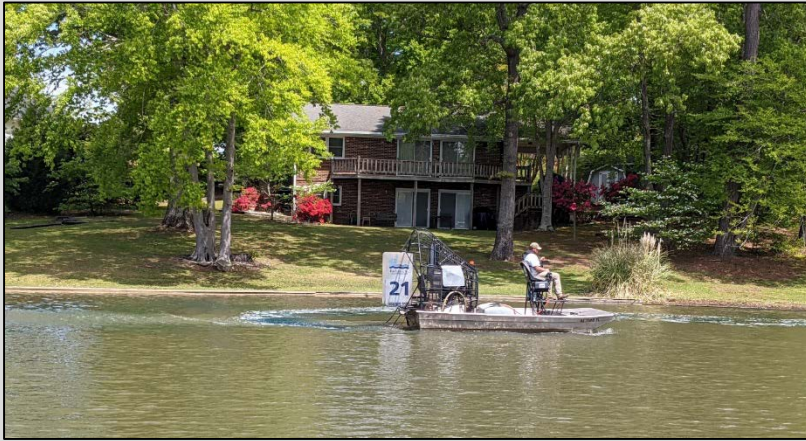
New Applicator

- Airboats
 - No hand spray applications
- New patented application system
 - Targets the mats along the bottom

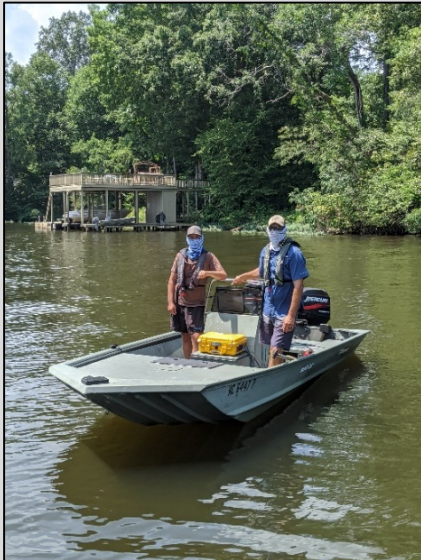
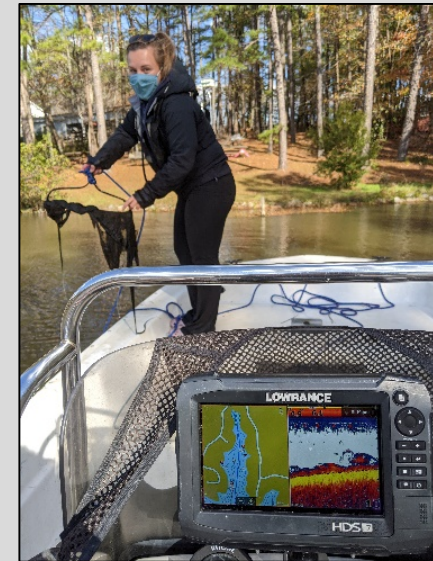
Methods of Evaluation:

- Monthly Biosonic Scans (March – December)
- Viability Samples (December)

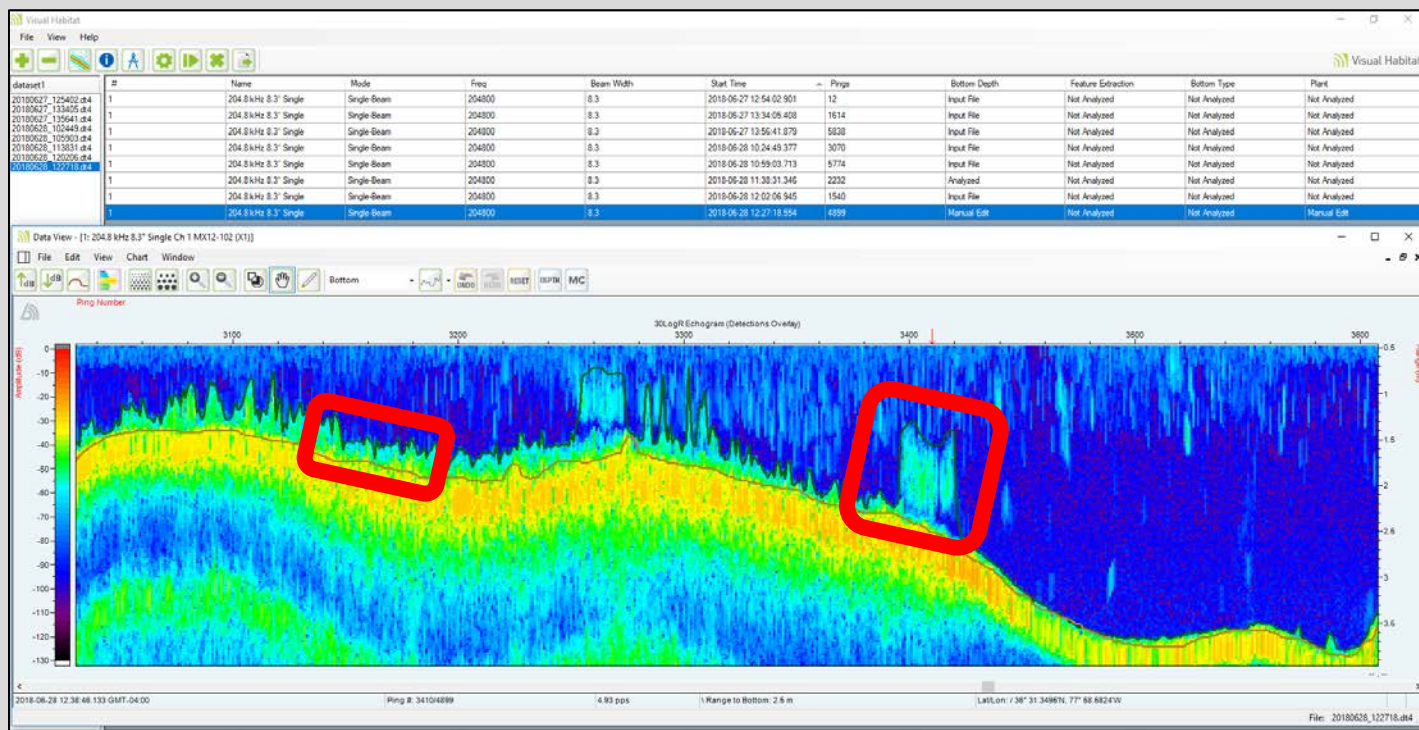
- **Monthly Biosonic Scans (March – December)**
 - Scanning whole treatment area
 - Capturing changes for across entire treatment area

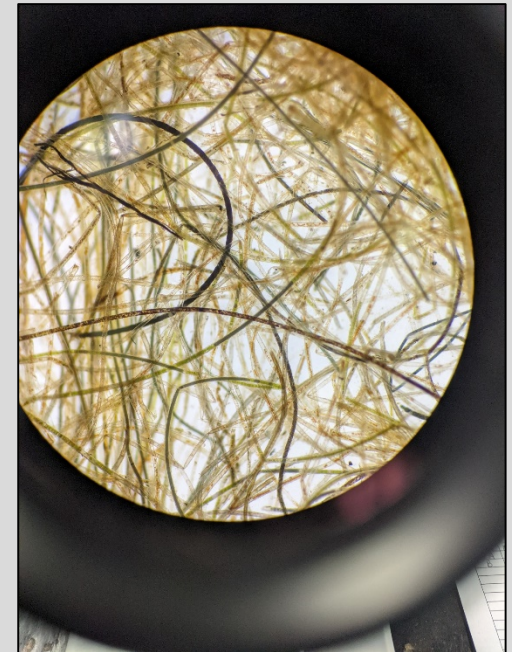
- Monthly Biosonic Scans (March – December)
- **Viability Samples (December)**

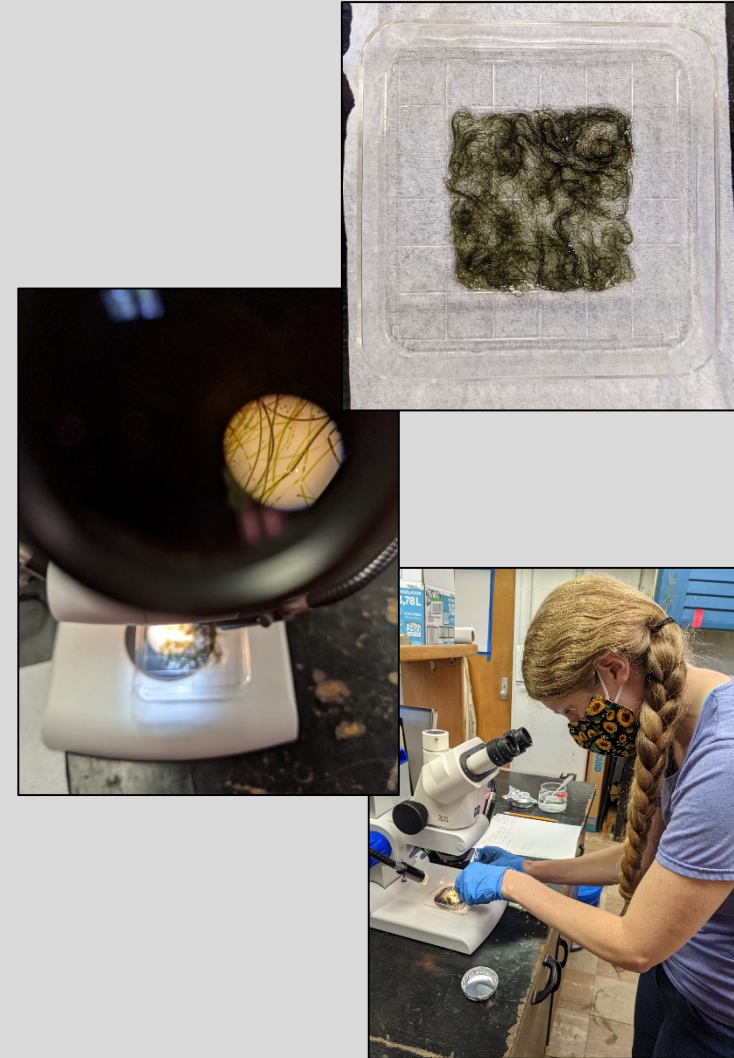
- Field samples were collected in December from:
 - Hawtree (experimental / multi-year)
 - Site 18 & 19 (1st Year)
 - Controls
- Samples were collected from two sites within each treatment area
- Two samples from each site were analyzed
- Viability was quantified by two separate readers

Determine what percent of the lyngbya in the viewing area was alive

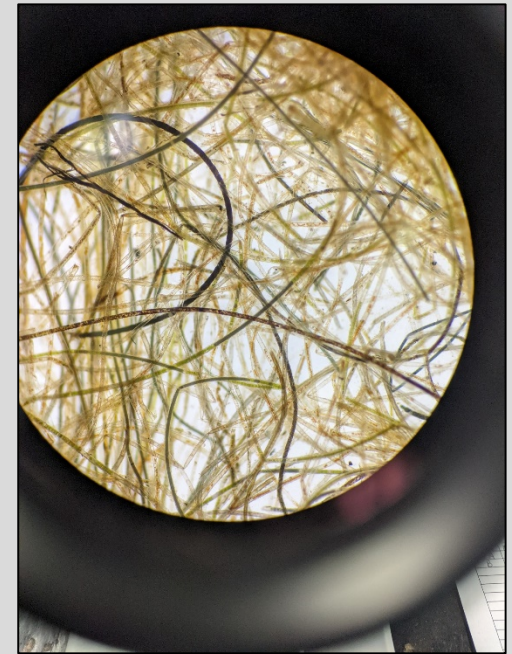
Viability

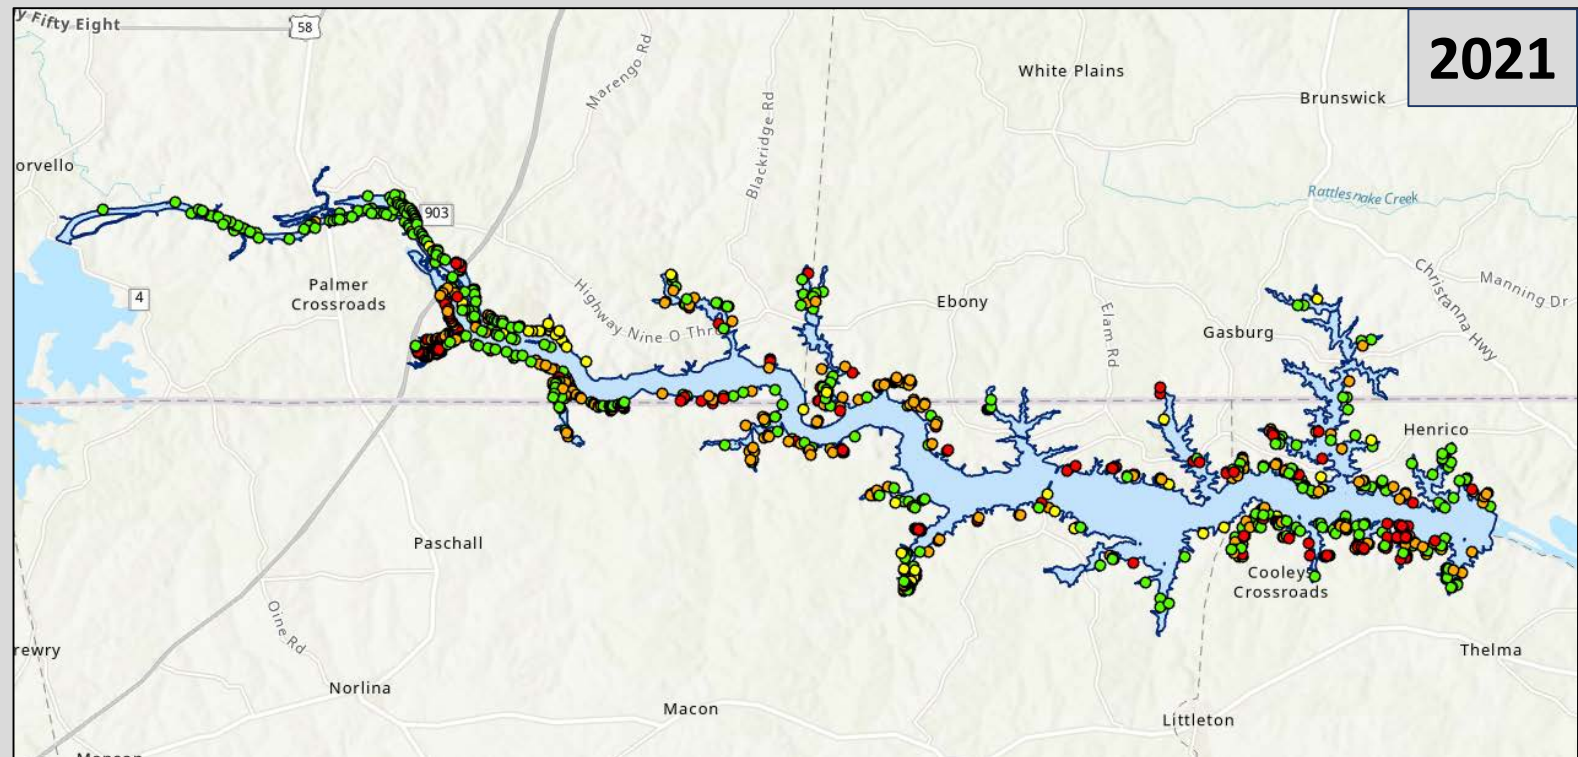
Estimated Lyngbya Acreage: 1,317 acres
